Exploratory Analysis of the Impact of Ventilation on Strip Mall Fires

Craig Weinschenk
Robin Zevotek

UL Firefighter Safety Research Institute
Columbia, MD 20145

April 17, 2020

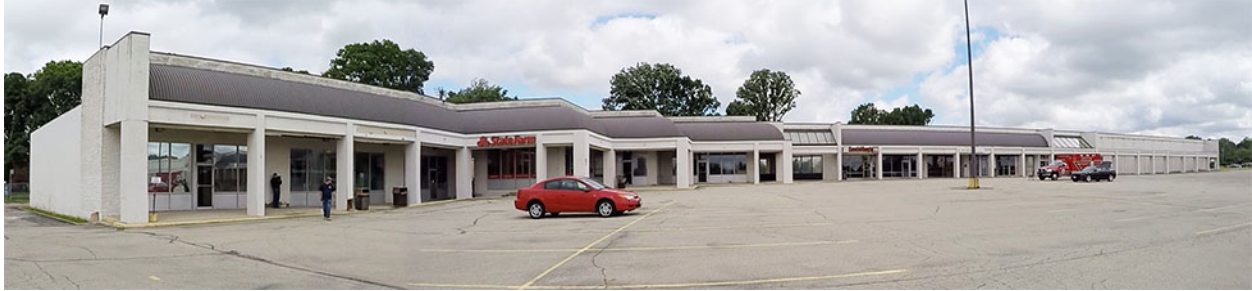
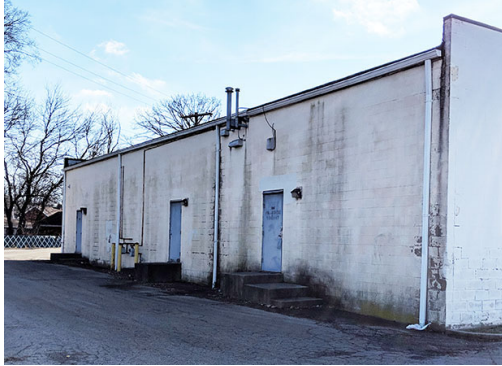
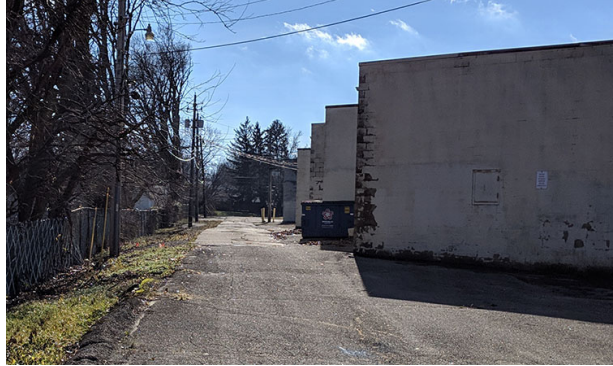
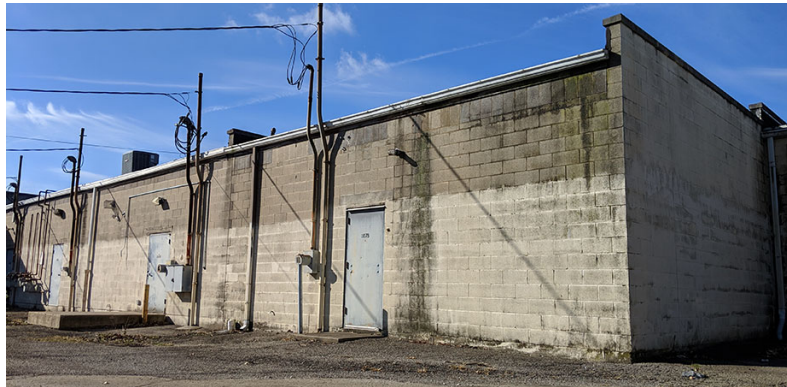
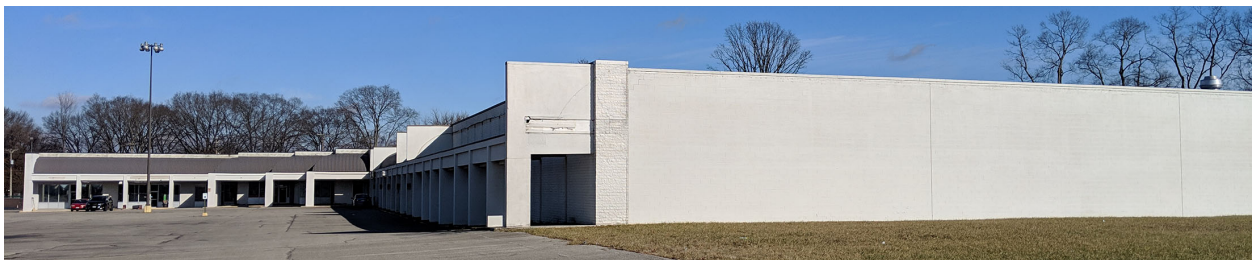
Figure 2.3: Images of the exterior of the Skyway Plaza shopping center in Fairborn, Ohio, utilized for these experiments.

(a) Side A (Front)

(b) Side B

(c) Side C (Access Road)

(d) Side C (Example of Typical Rear of Units)

(e) Side D

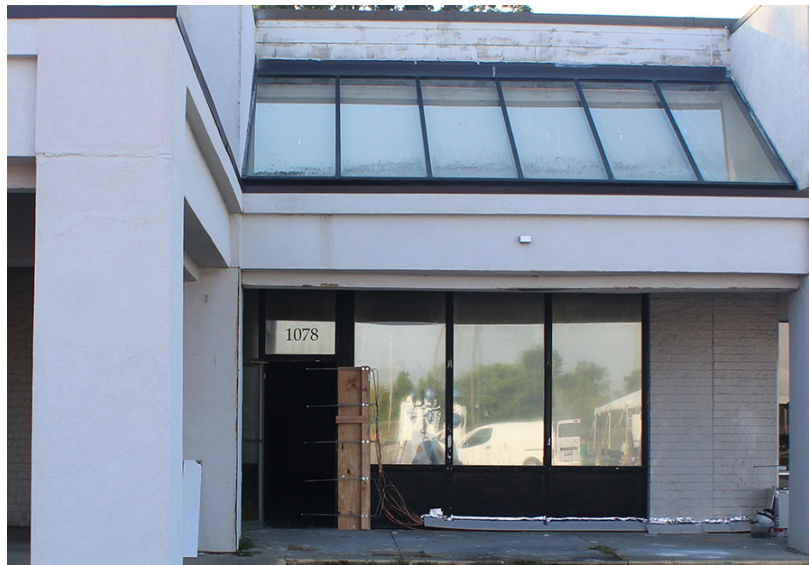
Figure 2.7: Image and dimensioned illustration of the front window wall in unit 1078.

(b) Front Elevation Photo

The front wall had a series of double-pane glass windows and aluminum panels, both in aluminum frames. Figure 2.7 illustrates the configuration and dimensions of the glass and aluminum panels and presents an image of the front elevation.

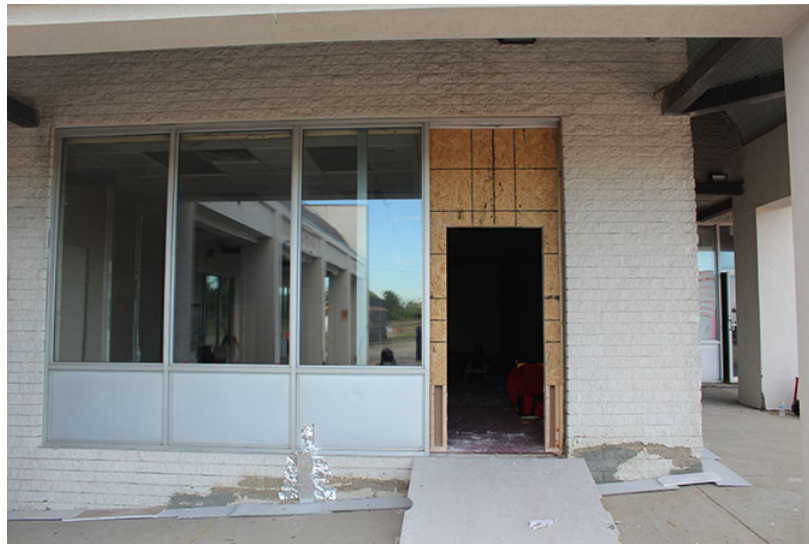
Figure 2.12: Image and dimensioned illustration of front window wall in unit 1074.

(b) Front Elevation Photo

The front wall had a series of double pane glass windows and aluminum panels, both in aluminum frames. Figure 2.12 illustrates the configuration and dimensions of the glass and aluminum panels as well as presents an image of the front elevation.

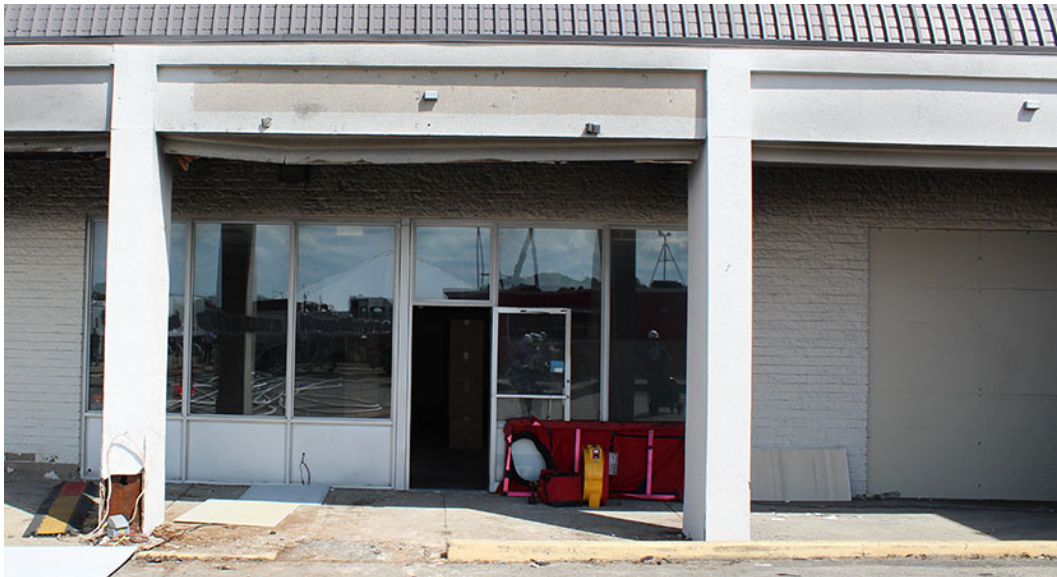
Figure 2.15: Image and dimensioned illustration for the front window wall of unit 1069–1071.

(b) Front Elevation Photo

The front wall had two sets of double-pane glass windows and aluminum panels, both in aluminum frames. The set in the AD corner was covered with 1/2 in. gypsum wall board from the exterior. The set in the AB corner remained uncovered. Figure 2.15 illustrates the configuration and dimensions of the glass and aluminum panels in the AD corner and presents an image of the front elevation.

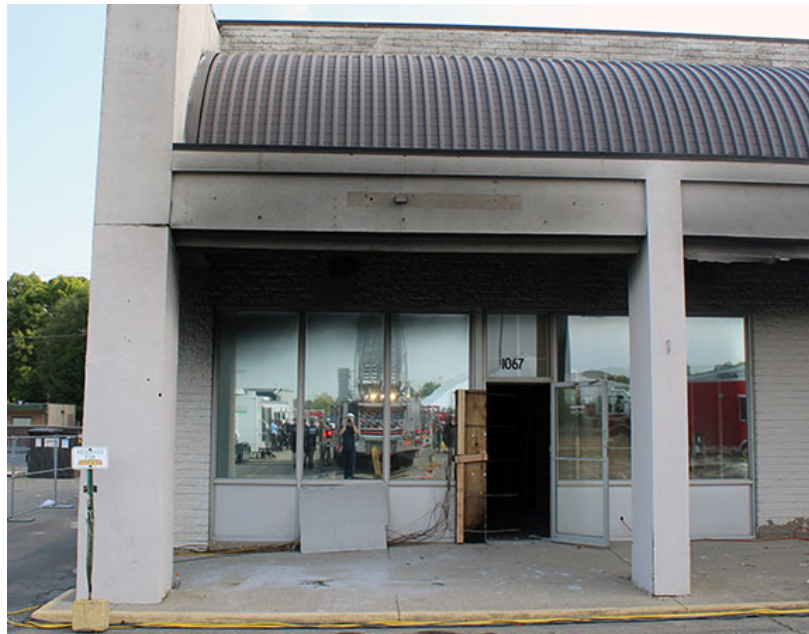
Figure 2.18: Image and dimensioned illustration for the front window wall of unit 1067.

(b) Front Elevation Photo

The front wall had a series of double-pane glass windows and aluminum panels, both in aluminum frames. Figure 2.18 illustrates the configuration of the panels and presents an image of the front elevation.

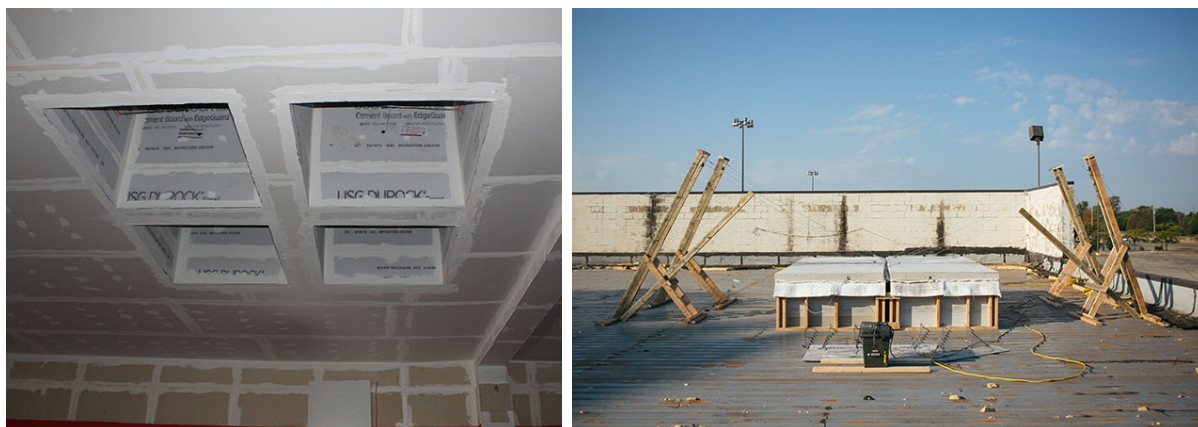
Four vertical 4 ft by 4 ft (1.2 m by 1.2 m) roof vent holes were cut in the roof prior to any fire experiments. A vertical chimney was constructed for each hole that ran from the underside of the gypsum wall board ceiling up through the metal roof trusses, through the roof, and extended beyond the roof. The total height of each chimney was 4 ft 7 in. (1.4 m) from the underside of the ceiling to the top. The chimneys were lined with two layers of 1/2 in. cement board. The roof vents were capped with wood framed louvered caps, covered with 1/2 in. concrete board. To open the vents remotely from the ground, a pulley system was installed with metal cables running over the side B and side D walls. Figure 2.19 presents the roof vent holes from the underside and above.

(a) Underside of Roof Vents

(b) Top Side of Roof Vents

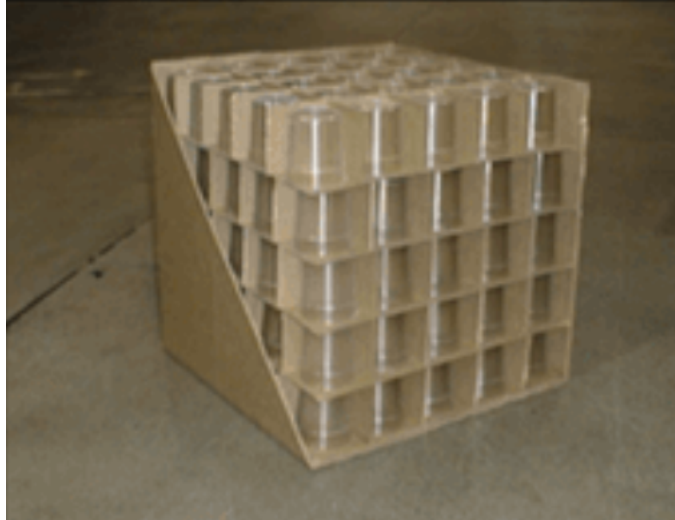
Figure 2.20: Image of the internal configuration of the plastics cups and cardboard in side a Group A plastic commodity box. The exterior cardboard has been cut away to reveal the internal structure.

cups. The cups are packaged upside down in a grid fashion with 25 cups per layer, separated by a single layer of corrugated cardboard between cups and between layers. Each box had five layers of cups, for a total of 125 per cups per box (Figure 2.20). The commodity boxes were purchased pre-packaged from a third-party vendor.

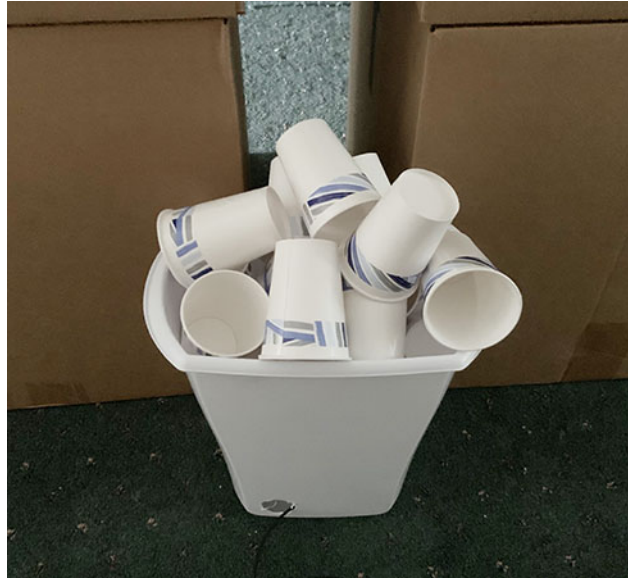
Figure 2.21: Image of the ignition source utilized in these experiments. The source consisted of wax paper cups and newspaper in a plastic trash can.

The ignition package for the fuel was a 3 gal (11.4 L) plastic trash can filled with twenty-seven 9 oz (266.2 mL) wax paper cups and newspaper. The package was ignited by a match book with a nichrome wire running through the match heads connected to a 24V power supply (i.e., an electric match). A 1.0 in. (2.5 cm) hole was drilled in the bottom of the trashcan to pass the wire for the electric match into the can. The ignition package was placed adjacent to a row of commodity boxes as presented in Figure 2.21.

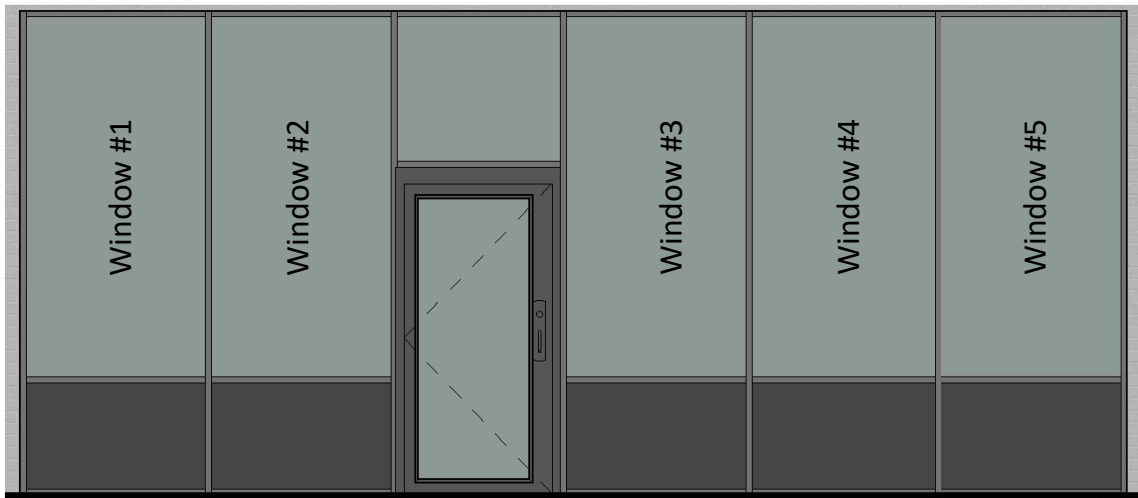
Figure 3.12: A schematic highlighting the window numbering for purposes of horizontal ventilation

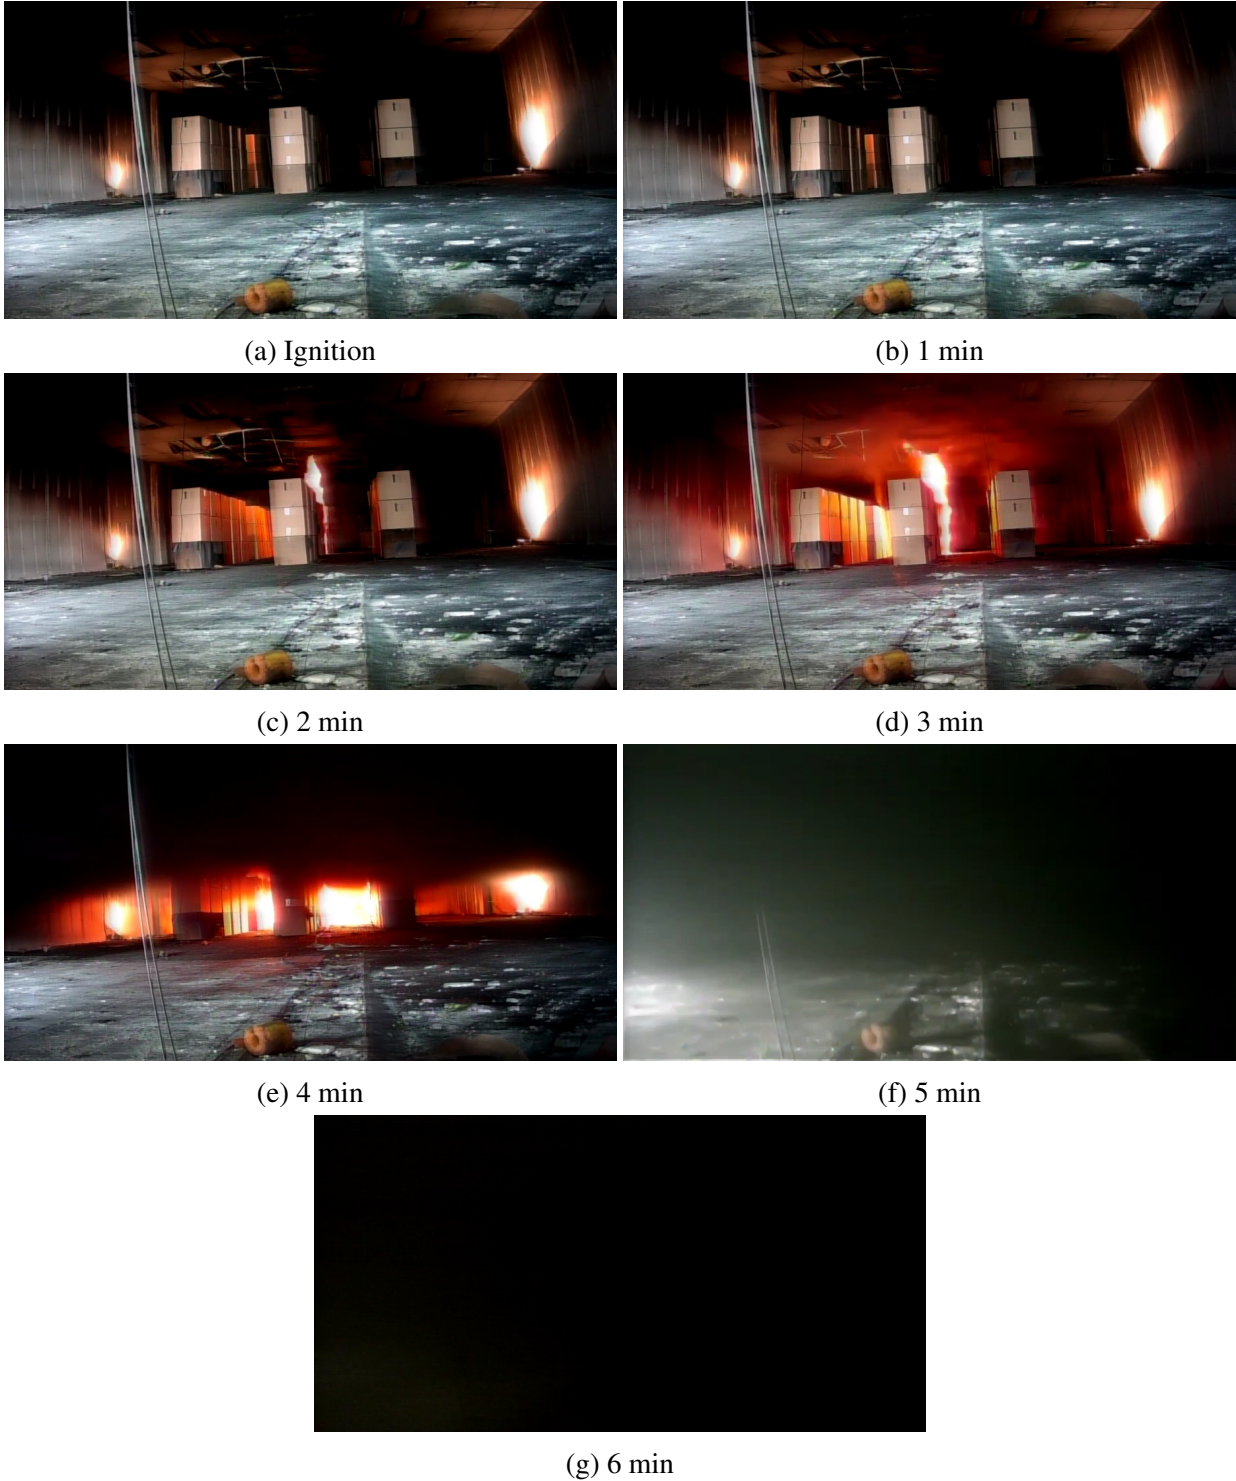
Figure 3.14: Sequential interior images during Experiment 2 looking toward side C from the side A. The interior camera was lost after 6 min due to thermal damage from the fire.

The gas temperatures recorded in Experiment 2 are presented in Figure 3.13 starting at ignition and ending at the completion of the experiment. Following ignition, it took 1 min 30 s for an increase in gas temperature to be recorded at the thermocouples 13 ft (4.0 m) above the floor in the fire compartment. The damage to the ceiling grid from Experiment 1 allowed heat to penetrate the drop ceiling faster in Experiment 2. Flames were visible impinging on what was left of the drop ceiling 2 min after ignition (see Figure 3.14c).

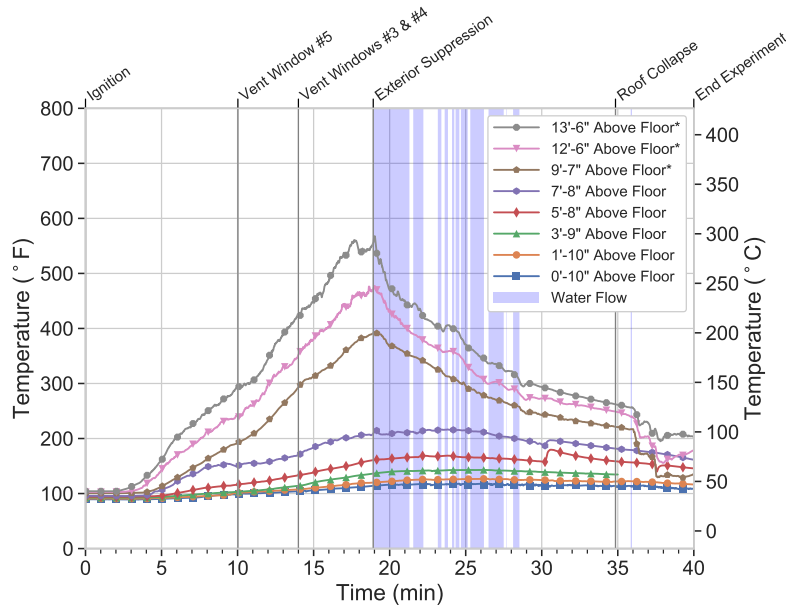
Figure 3.17: Temperatures recorded in the rear room with a closed door during Experiment 2.
 * sensor was above the drop ceiling.

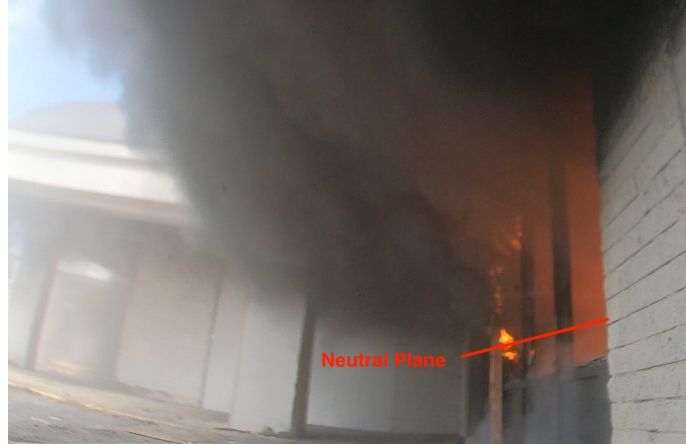
Figure 3.18: Image and approximate location of the neutral plane in the openings on the front of Unit 1078 during Experiment 2 following the ventilation of the AD left and center window panes 18 min after ignition. The red line approximates the height of the neutral plane.

The ventilation area above the neutral plane was larger than the area below the neutral plane, with the end result being more exhaust flow than inflow (see Figure 3.18). The volume of gases being exhausted exceeded the volume of gases being drawn in, with the result being a decrease in pressure inside the unit.

At 18 min after ignition, flames were visible on the exterior camera (see Figure 3.18). The flames increased the radiation on the lower three temperature sensors in the inlet portion of the front door, which recorded the additional radiation as an increase in temperature (see Figure 3.16b).

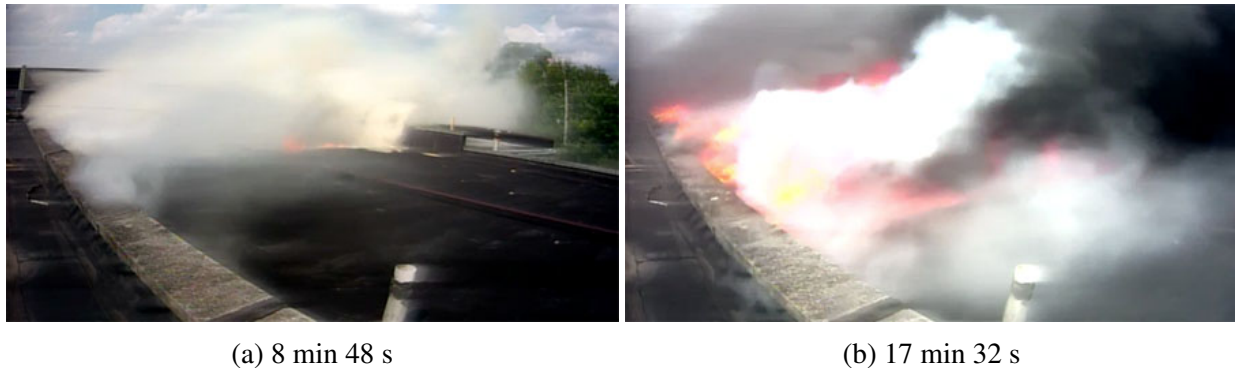
Figure 3.19: Images from the camera on the CD corner showing the ignition of the roofing material.

The foam insulation and rubber membrane on the roof near the HVAC unit ignited 8 min 48 s after ignition. The flames spread to the majority of the main volume roof by 17 min 32 s (see Figure 3.19).

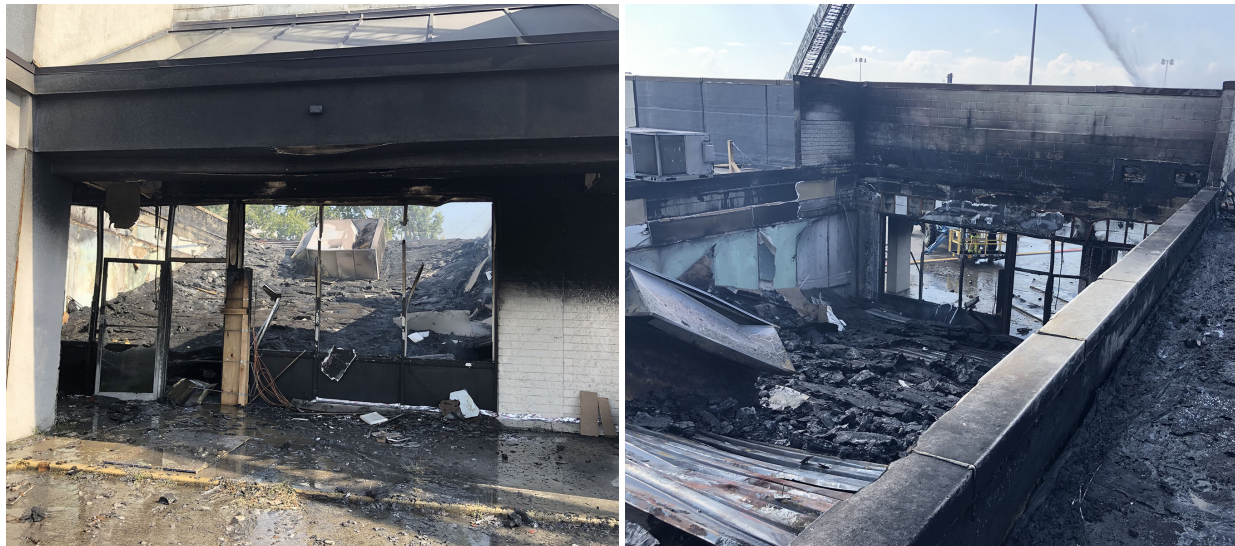
The roof collapsed in the front half of the unit at 34 min 51 s. As the roof joists in the unit heated they expanded, and pushed the front masonry wall toward side A. Once suppression had extinguished the fire, the joists cooled and retracted away from the front wall. No longer being supported by the wall, the front portion of the roof collapsed in a lean-to style collapse. Further discussion on the collapse mechanism is discussed in Section 4.3.

(a) Front Elevation

(b) From Adjacent Roof

The experiment concluded at 40 min when the visible flames had been extinguished. Figure 3.21 shows images of the collapsed roof structure after the experiment concluded.

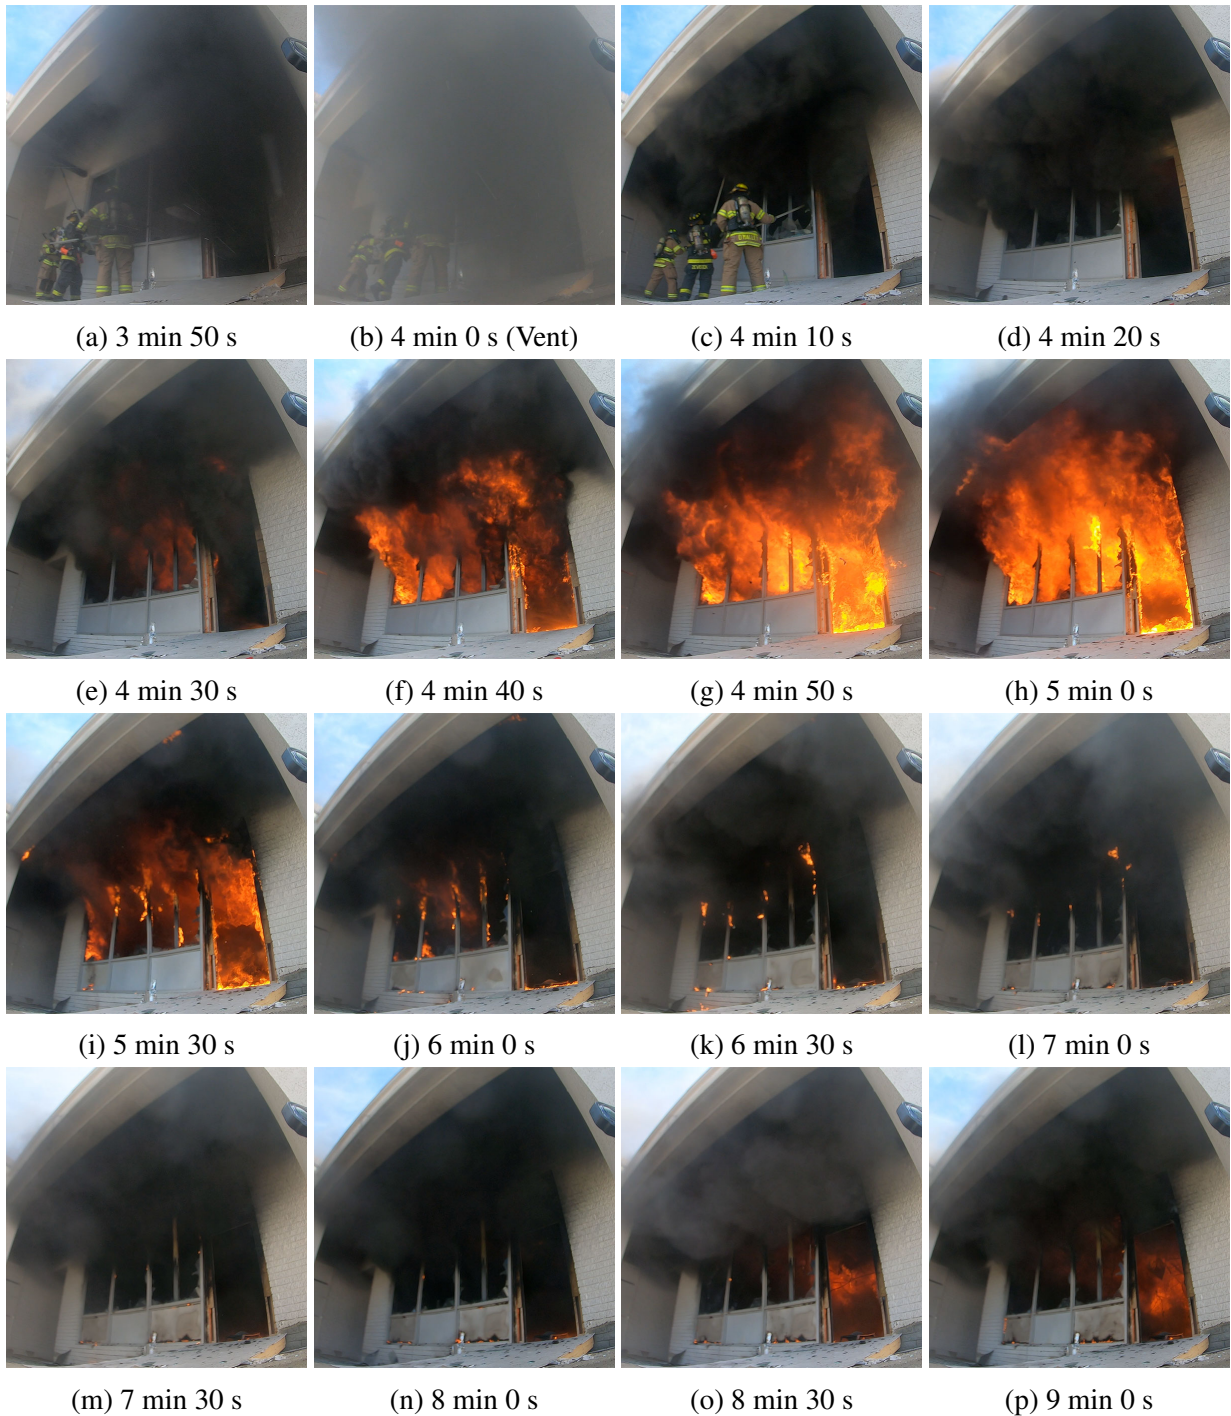
Figure 3.27: Changes in visible fire from side A after horizontal ventilation of glass in Experiment 3. Rows 1 & 2 show rapid changes from 10 s before ventilation to 1 min after (3 min 50 s to 5 min). Rows 3 & 4 show the transition into a temporary decay phase and subsequent regrowth over the following 4 min.

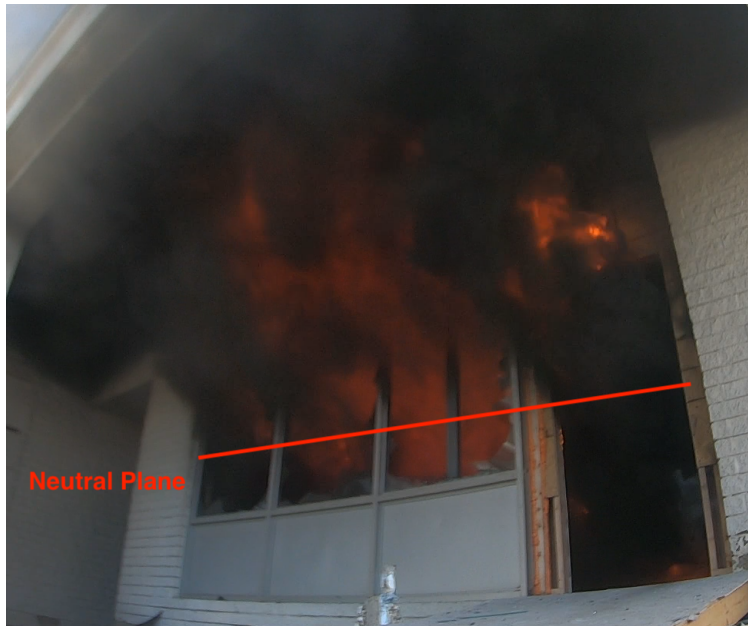
Figure 3.29: View of the front of the unit from the exterior camera 4 min 30 s after ignition, 30 s after ventilation occurred, during Experiment 3. The red line illustrates the approximate location of the neutral plane.

The ventilation also impacted the differential pressure between the unit and the exterior. Immediately following the window ventilation, the pressure dropped from 0.013 psi (90 Pa) to a negative pressure (see Figure 3.26). The negative pressure can be attributed to the volume of exhaust exiting the unit exceeding the volume of gases entering the unit. The neutral plane was located approximately one third of the way up the windows (see Figure 3.29). The top two thirds of the window area was exhaust with the bottom third and the bottom half of the door as intake. The large exhaust area resulted in the volume of gases being exhausted exceeding the volume of gases being drawn in, and this a negative pressure was recorded on the pressure transducers.

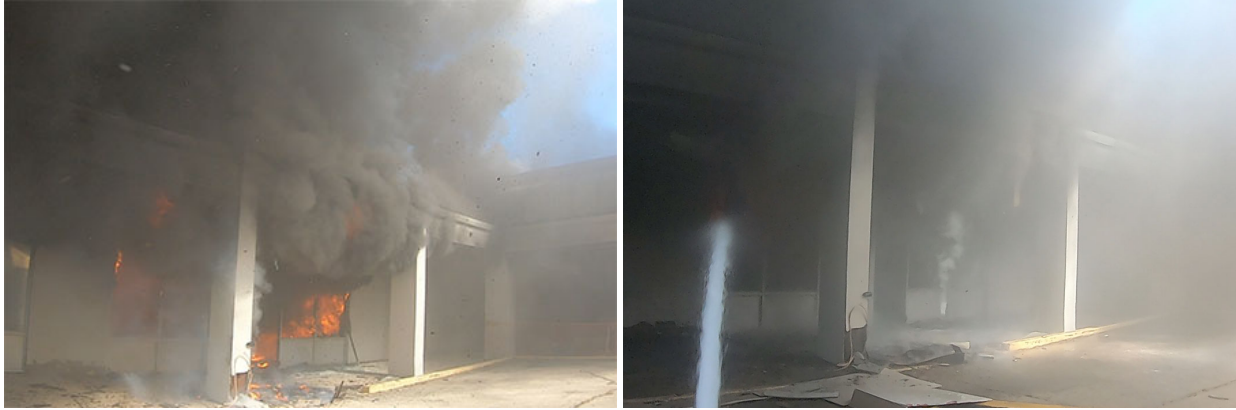
(a) Just prior to the initial suppression.

(b) 30 s after the initial suppression started.

Figure 3.38: Conditions from the viewpoint of the nozzle firefighter at 11 min 30 s just prior to the initial suppression and 30 s later in Experiment 4.

Temperatures steadily increased over the following 7 min 30 s. Peak temperatures prior to suppression were recorded 1 in. (2.3 cm) below the metal roof deck, exceeding 1,750 °F (816 °C). During this time flames were present at all of the open vents where the hot fuel mixed with fresh air (oxygen) (see Figure 3.38a).

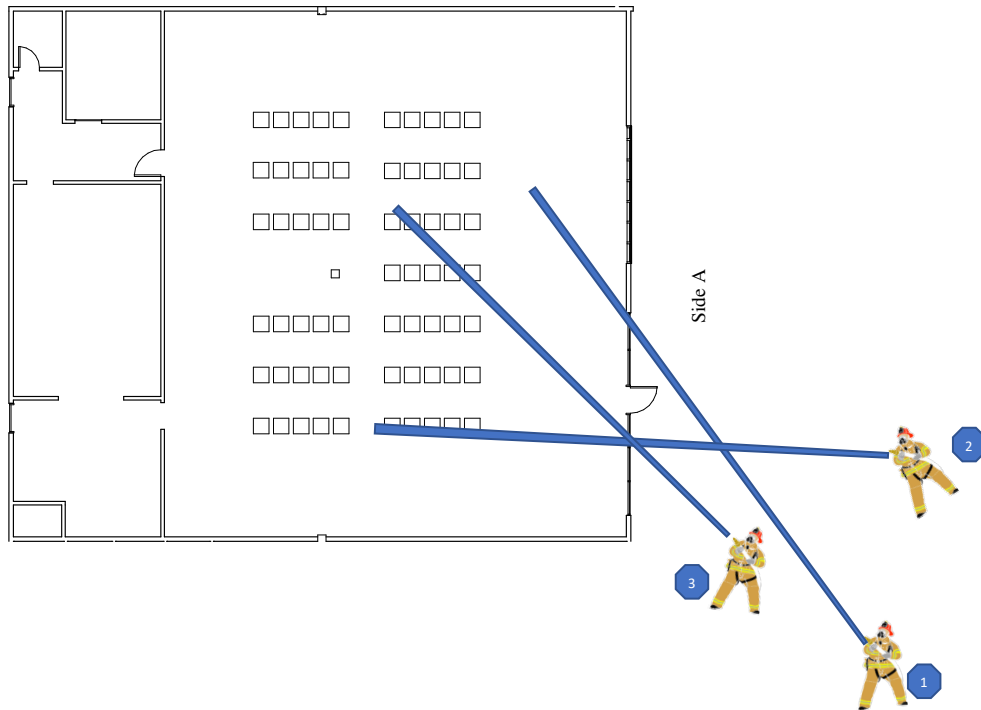
Figure 3.39: Graphic representation of water application locations and general direction during Experiment 4.

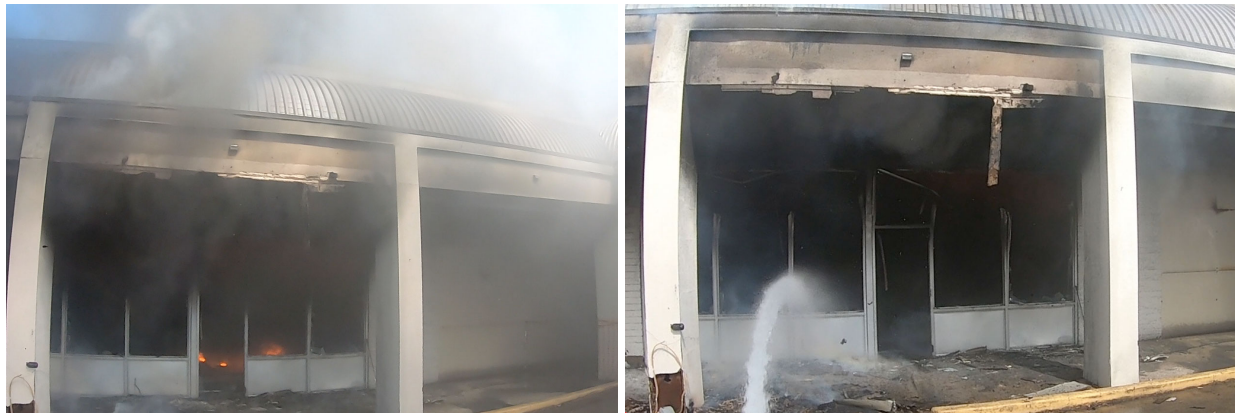
(a) Just prior to the second suppression.

(b) 30 s after the second suppression started.

Figure 3.41: Conditions from the viewpoint of the nozzle firefighter at 12 min 21 s, just prior to initiating the second exterior water application, along with 30 s later (Experiment 4).

When the second water application appeared to have had the desired impact (see Figure 3.41), the suppression crew repositioned the handline to position 3 in Figure 3.39, closer to the unit than position 1. Temperatures in the AB and CD quadrants, where the line was now able to reach, dropped from in excess of 1,500 °F (816 °C) to under 500 °F (260 °C) during the 1 min 30 s the line was flowed (see Figure 3.33a). The drop in temperature caused gas contraction, and the differential pressure dropped below ambient to -0.1 psi (-69 Pa) and then returned to near ambient (see Figure 3.35).

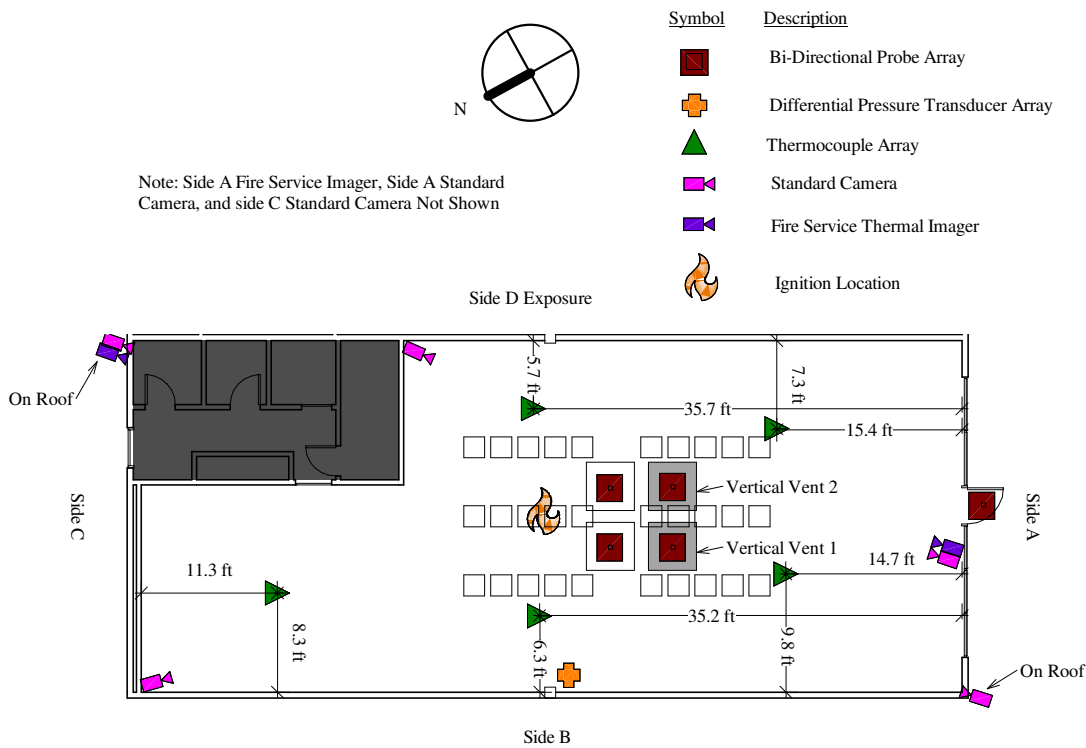
Figure 3.43: Instrumentation plan for unit 1067. Not shown are the locations where wind speed, wind direction, ambient temperature, and suppression water flow were recorded. The dark gray shaded area was isolated from the experimental volume for these experiments.

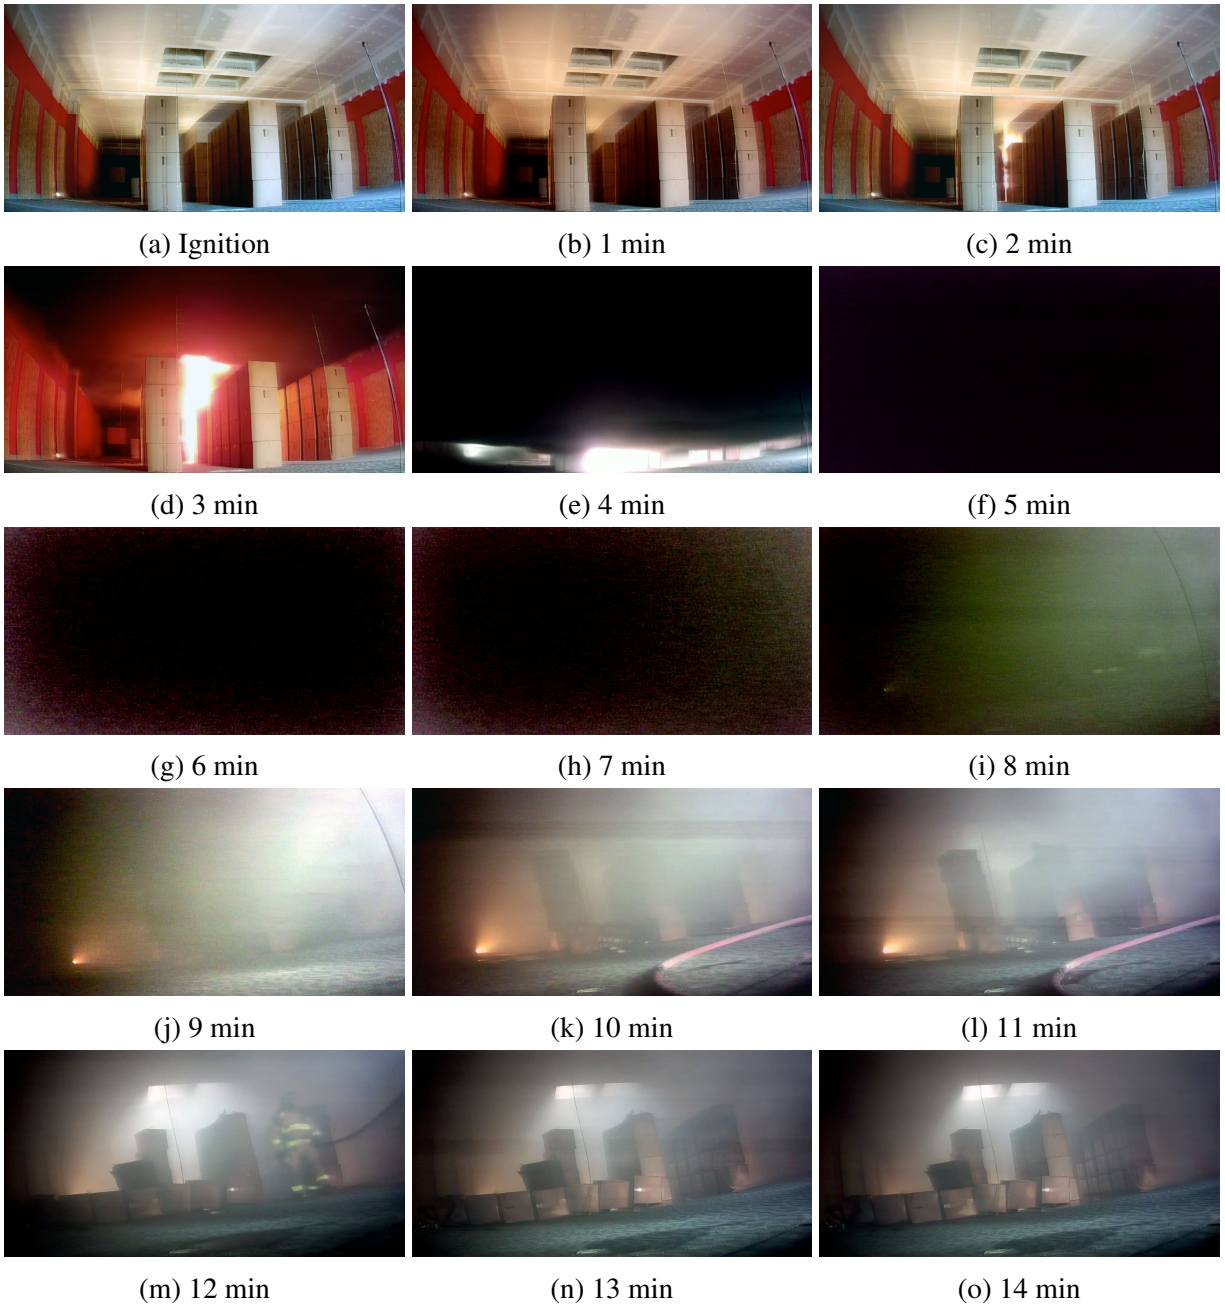
Figure 3.45: Sequential interior images during Experiment 5 looking toward side C from side A.

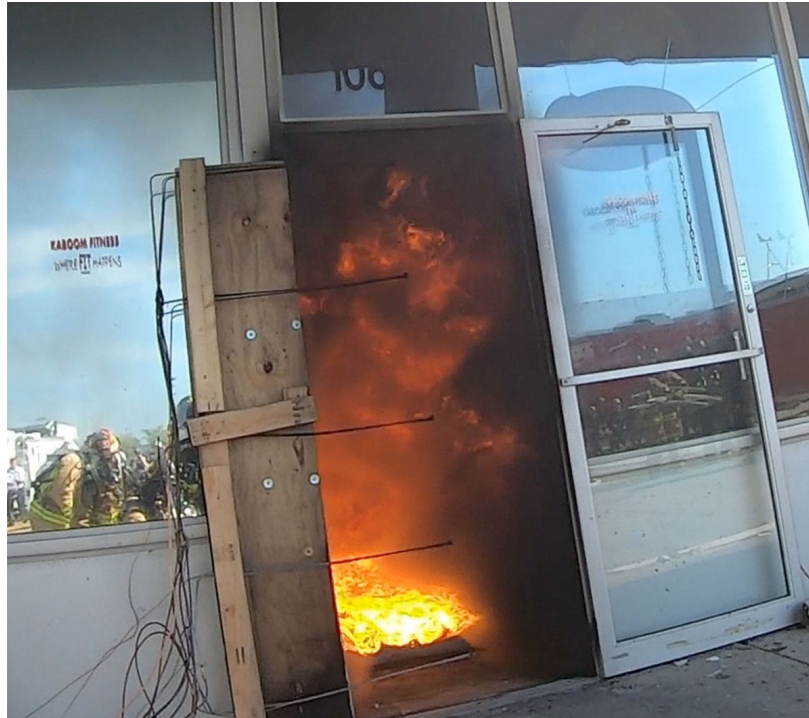
Figure 3.61: Flames at the front door 14 s prior to suppression (9 min 10 s after ignition) in Experiment 6.

remained below 150 °F (66 °C). At 9 min 10 s, the gases at the front door ignited. The flames provided additional radiation (see Figure 3.61), which was recorded on the temperature sensors at the front door as an increase in temperature, see Figure 3.58b.

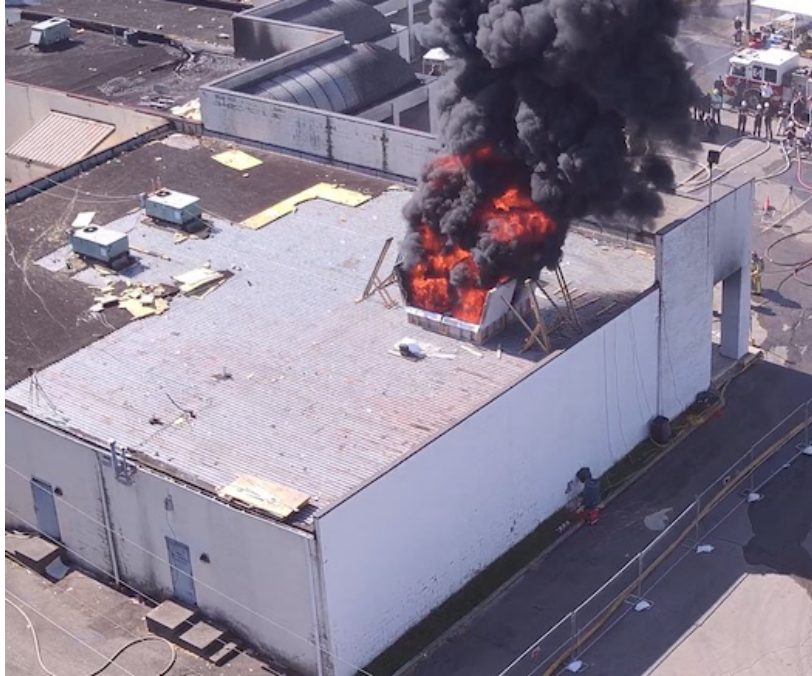
Figure 3.62: A drone image of the roof vents, looking from the BC corner toward the AD corner 10 s prior to suppression (9 min 14 s after ignition) in Experiment 6.

The larger fire size on the interior resulted in higher temperatures in the roof vents. Temperatures recorded in all four vents exceeded 2,000 °F (1,093 °C). As the hot smoke exhausted out of the open vents, it mixed with the oxygen on the exterior and flaming combustion occurred. Flames were visible from all four vents (see Figure 3.62).

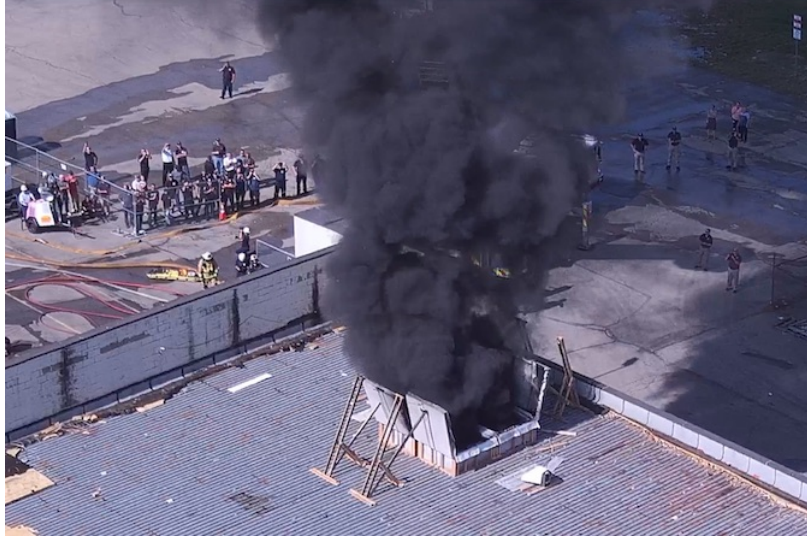
Figure 3.64: A drone image of the roof vents looking from the CD corner toward the AB corner 30 s after the initial suppression (9 min 54 s after ignition) in Experiment 6.

Suppression extinguished the flames in the gases at the front door and temperatures decreased (see Figure 3.58b). Flames were no longer visible from the roof vents 30 s after the initial suppression (9 min 54 s), and temperatures in the roof vents decreased (see Figure 3.64). The temperatures in the roof vents dropped from in excess of 2,000 °F (1,093 °C) to under 500 °F (260 °C) within 2 min 30 s of the initial suppression (see Figure 3.59).

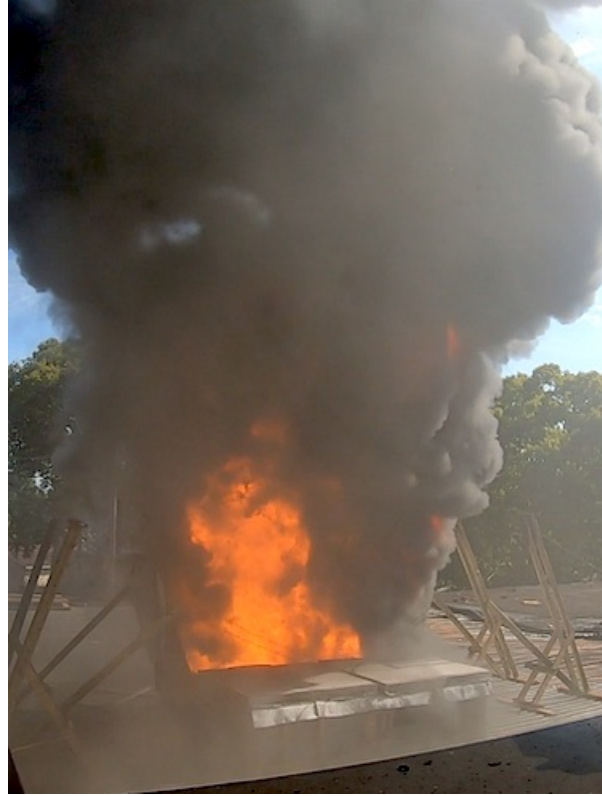
Figure 3.73: Image of the open BC and CD roof vents 30 s after ventilation occurred (6 min after ignition) during Experiment 7. The image was taken from the AB corner looking toward the CD corner.

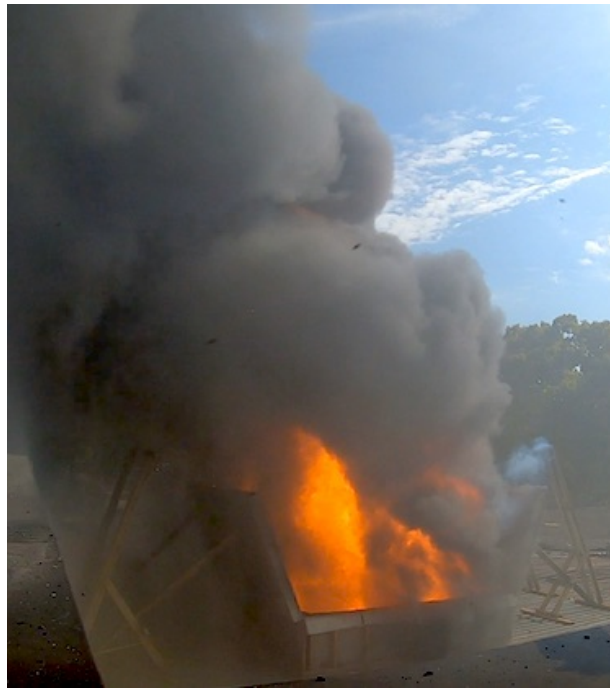
Figure 3.74: An image of the roof vents 10 s after ventilation occurred (7 min 40 s after ignition) during Experiment 7. Image was taken from the AB corner looking toward the CD corner.

Two additional 4 ft x 4 ft (1.2 m x 1.2 m) roof vents (the AB and AD vents) were opened 7 min 30 s after ignition, providing additional vertical ventilation. All four open vents recorded uni-directional exhaust with velocities exceeding 50 mph (22 m/s, see Figure 3.71). Temperatures recorded in the roof vents exceeded $2,250$ °F ($1,232$ °C) (see Figure 3.72). Flames were visible in the exhaust from the open roof vents 10 s following ventilation (see Figure 3.74). The additional exhaust provided was borderline in creating a uni-directional vent at the front door and windows. Although the velocity decreased, the top probe in the front door measured velocities that fluctuated

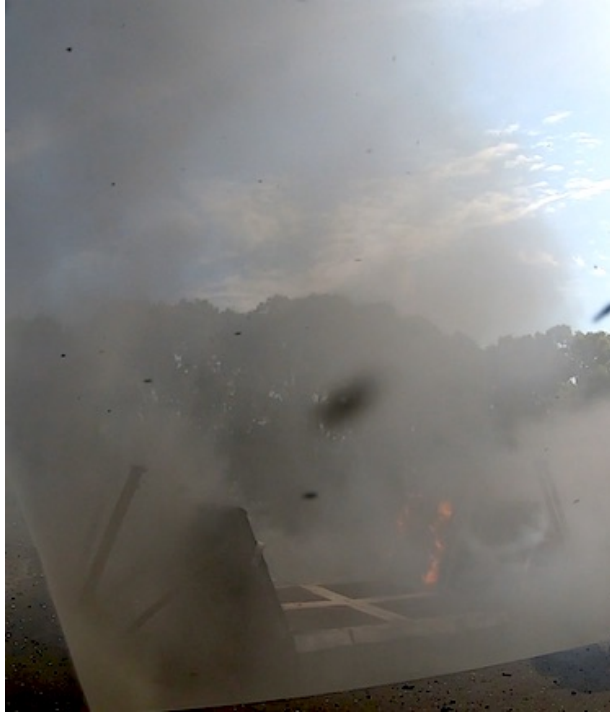
Figure 3.76: An image of the roof vents 30 s after suppression started (9 min 40 s after ignition) during Experiment 7. The image was taken from the AB corner looking toward the CD corner.

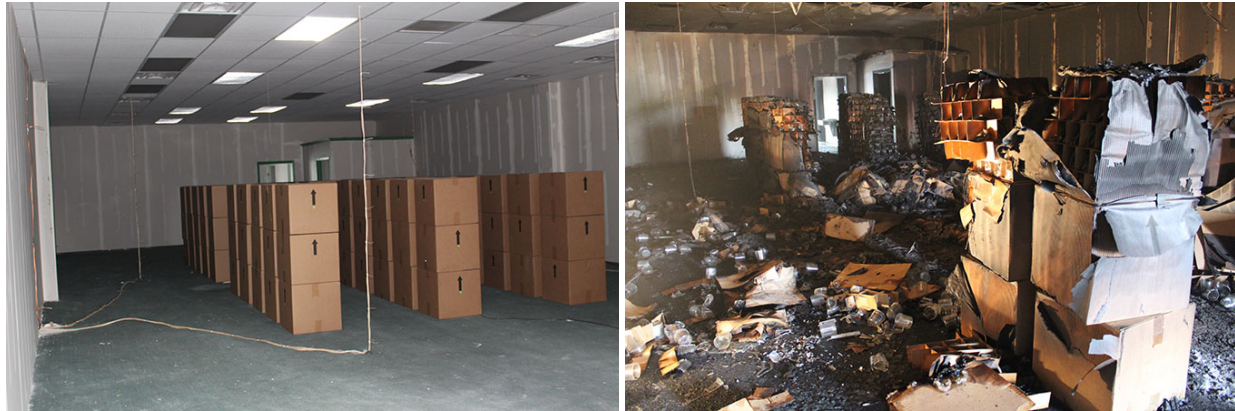
(a) Prior to Ignition

(b) After Suppression

Figure 4.2: Images of fuel package prior to ignition and after suppression (Experiment 1).

Following suppression, fuel remained (see Figure 4.2), indicating the decay stage was due to a lack of oxygen, not the lack of fuel. A visual estimation of the fuel remaining indicated approximately 40% had been consumed. The lack of oxygen limited the fire size, which resulted in a ventilation-limited fire. This was consistent with earlier research in commercial buildings [10] and furnished residential structures [1–4, 12, 13]. With no open windows or doors, the fires became ventilation
