Exploratory Analysis of the Impact of Ventilation on Strip Mall Fires

Craig Weinschenk
Robin Zevotek

UL Firefighter Safety Research Institute
Columbia, MD 20145

April 17, 2020

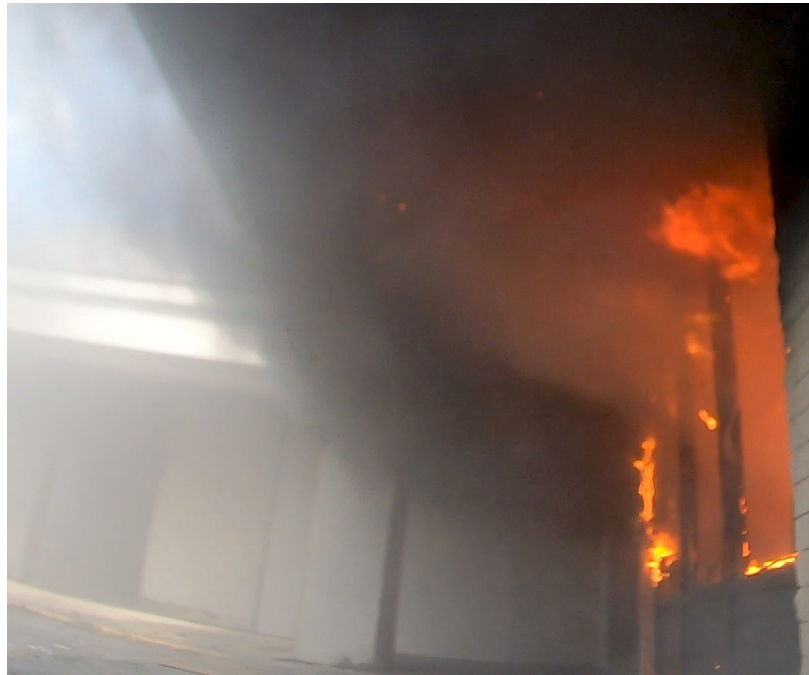
Figure 4.4: An image of flames venting out of the open front windows and door 18 min after ignition (Experiment 2).

Further horizontal ventilation was added when two more windows were opened (see Figure 3.12 – windows #3 and #4) 14 min after ignition. The second set of windows brought the total horizontal ventilation area to 105.8 ft² (9.8 m²). The openings provided oxygen to the ventilation limited fire and temperatures increased within 2 min, indicating conditions representative of a post flashover fire in the front of the unit between the open vents and the ignition point. Temperatures in the rear decreased (see Figure 4.3). Note the temperature nearest the floor in the BC quadrant – this sensor was most likely in contact with the concrete below the carpet because it remained below 600 °F (316 °C). Flames were visible exiting the open windows and door (see Figure 4.4).

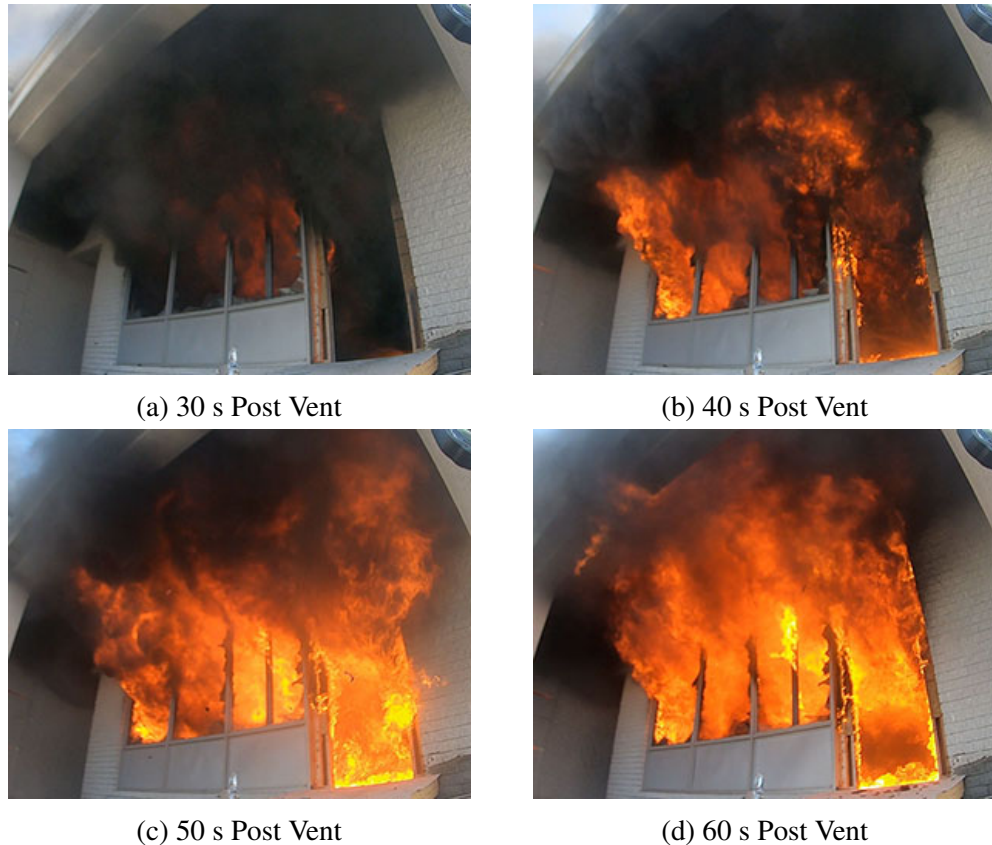
Figure 4.6: Sequential images showing the front of the unit starting 30 s after the ventilation of the front windows in Experiment 3. Images continue until 60 s after window ventilation had occurred.

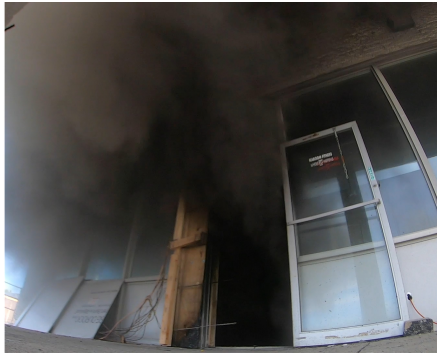
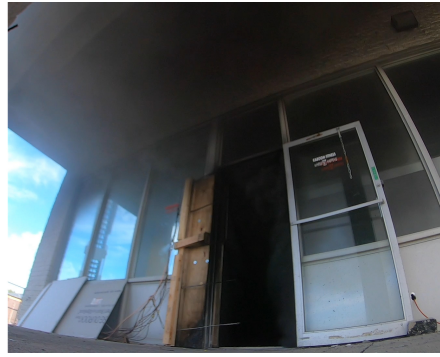
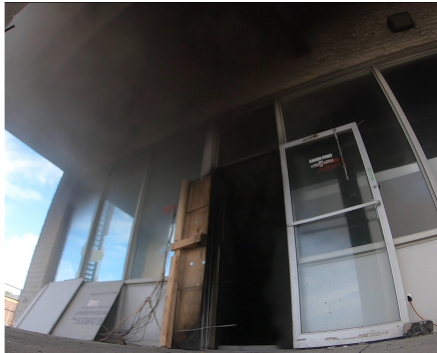
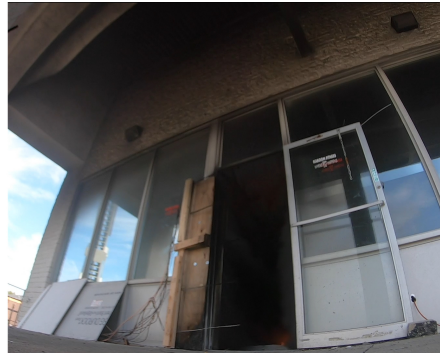
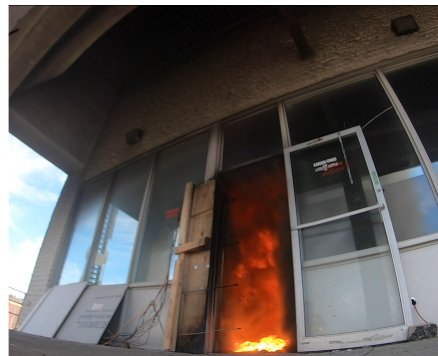
(a) Prior to Vertical Vents (5:30)

(b) 60 s Post Vent 1 (6:30)

(c) Prior to Vertical Vent 2 (7:30)

(d) 60 s Post Vent 2 (8:30)

(e) 120 s Post Vent 2 (9:30)

Figure 4.13: Changes in visible smoke and fire conditions at the front door after changes in vertical ventilation (Experiment 6).

Consider the smoke and fire conditions at the front door as function of increased vertical ventilation as shown in Figure 4.13. Prior to the first vertical vent action (see Figure 4.13a), there was bi-directional flow at the front door as shown in both Figure 4.8a and Table 4.3. As the vertical ventilation area increased (see Figure 4.13b–4.13d), the velocity profile at the door became unidirectional intake (see Figure 4.11a) and temperatures inside the front door rose (see Table 4.3) with minimal changes in visibility at the front door. At 2 min after the second set of vertical ventilation vents were opened, flames were visible at the front door.

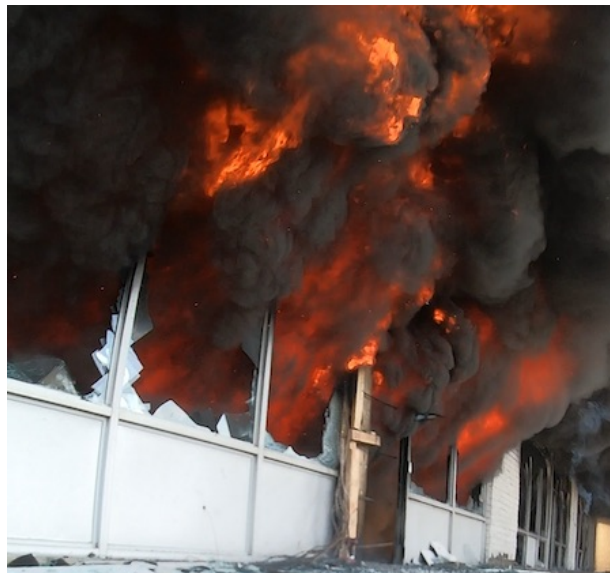
Figure 4.16: An image of flames venting out of the open front windows and door 1 min after horizontal ventilation, 5 min after ignition (Experiment 7).

In Experiment 7, the front windows were vented 4 min after ignition, providing 62.5 ft² (5.8 m²) of additional horizontal ventilation area. The total horizontal vent area following the opening of the windows was 81.5 ft² (7.6 m²). After the windows were opened, the rate of temperature rise slowed in the front of the compartment, then returned to previous conditions (see Figure 4.14). Flames were visible pushing out of the open front windows and front door 1 min after the horizontal ventilation occurred (see Figure 4.16). The flow path increased in width as it now included the bottom of the door and windows as the intake, and the top of the door and windows as the exhaust.

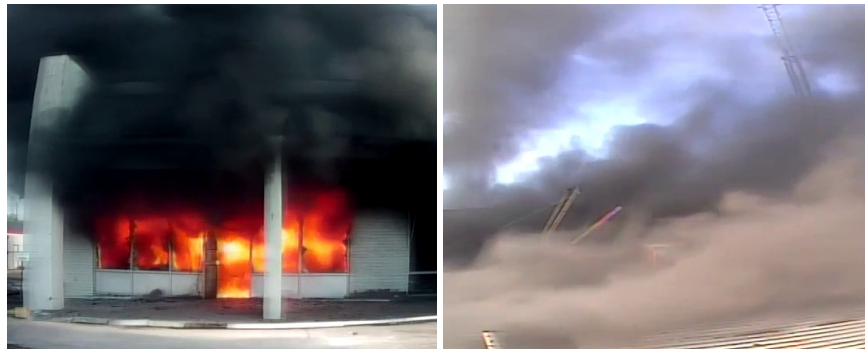
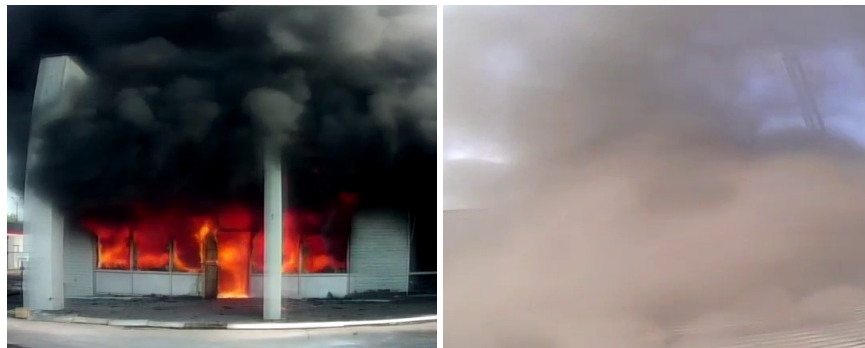
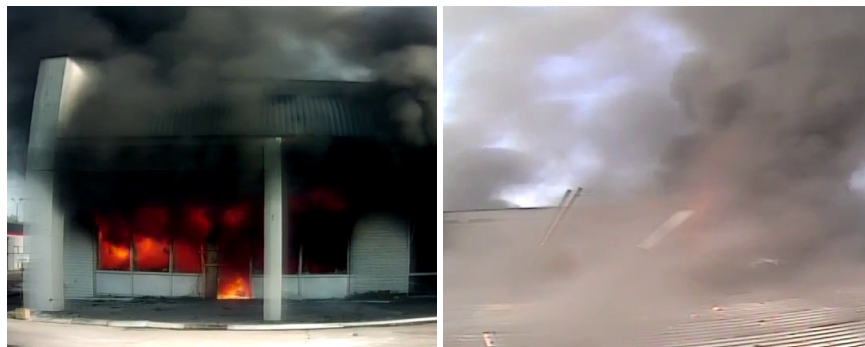
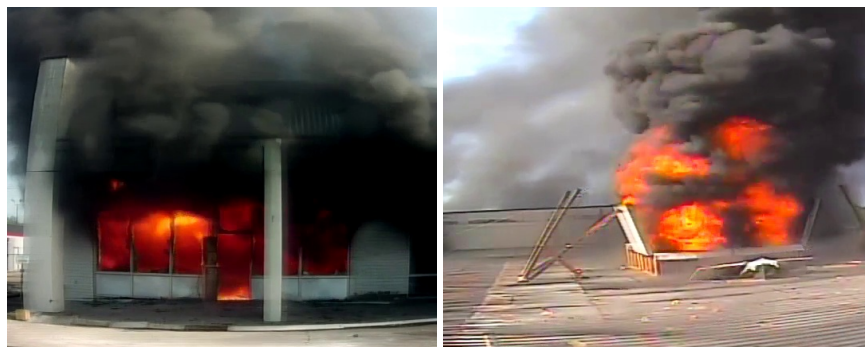
Figure 4.18: Smoke and fire conditions associated with the first vertical ventilation on conditions at the front of the unit (left column) and roof (right column) from 10 s before vertical ventilation to 20 s after. The vertical openings combined for a total of 32 ft² (3.0 m²), and the horizontal opening was 81.5 ft² (7.6 m²) (Experiment 7).

A roof vent 32 ft^2 (3.0 m^2) in area was opened 5 min 30 s after ignition. Following the vertical ventilation, an additional flow path was established. The initial flow path that started and ended at the front door and windows was supplemented by a flow path between the horizontal opening on the front and the open roof vents. The velocity of the gases exiting the top of the horizontal opening on the front decreased (see Figure 4.17a) as the open vertical vents exhausted products of combustion through the roof vents (see Figure 4.17b). Flames were visible both at the front opening and the open roof vents (see Figure 4.18).

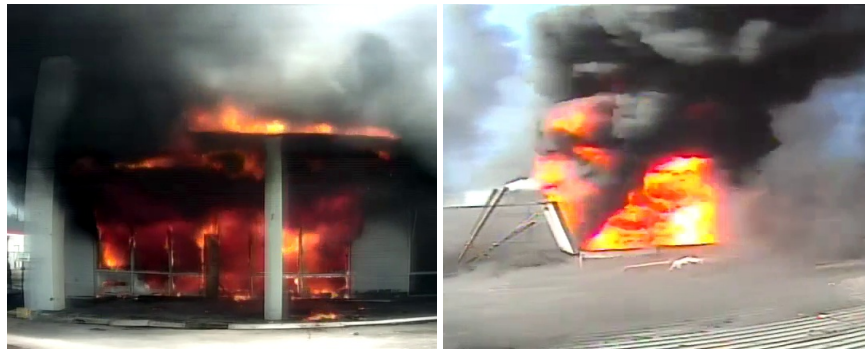
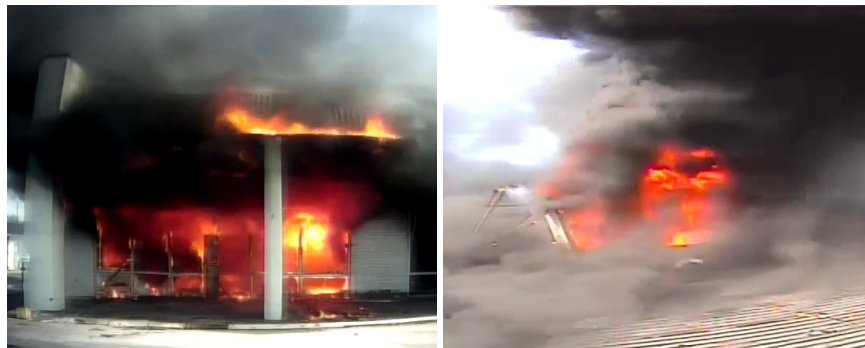
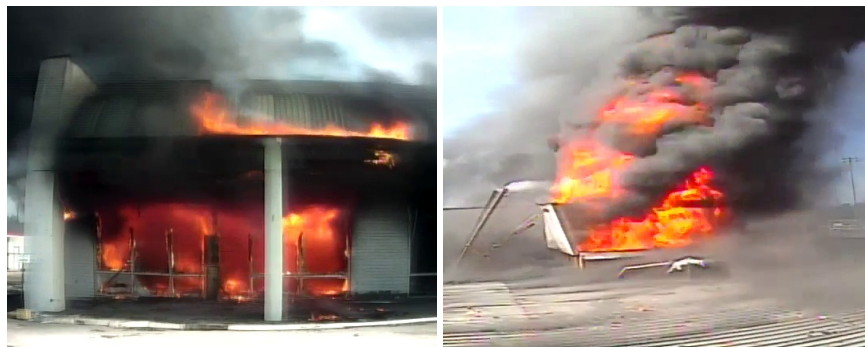
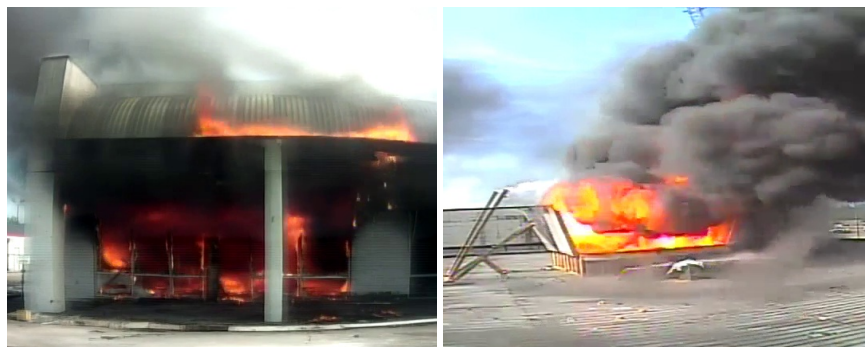
Figure 4.20: Smoke and fire conditions associated with the second vertical ventilation for Experiment 7 on conditions at the front of the unit (left column) and roof (right column) from 10 s before ventilation to 20 s after ventilation. The vertical vent area was 64 ft^2 (6.0 m^2), and the horizontal vent area was 81.5 ft^2 (7.6 m^2).

An additional 32 ft² (3.0 m²) of vertical ventilation was provided at 7 min 30 s after ignition. The total size of the vent areas was 81.5 ft² (7.6 m²) of horizontal area and 64 ft² (6.0 m²) of vertical area. The additional ventilation increased the flow between the front openings and the roof vents (see Figure 4.19). Following the additional vertical vents, flames retracted into the unit in the front, and flames were visible from all four roof vents (see Figure 4.20).

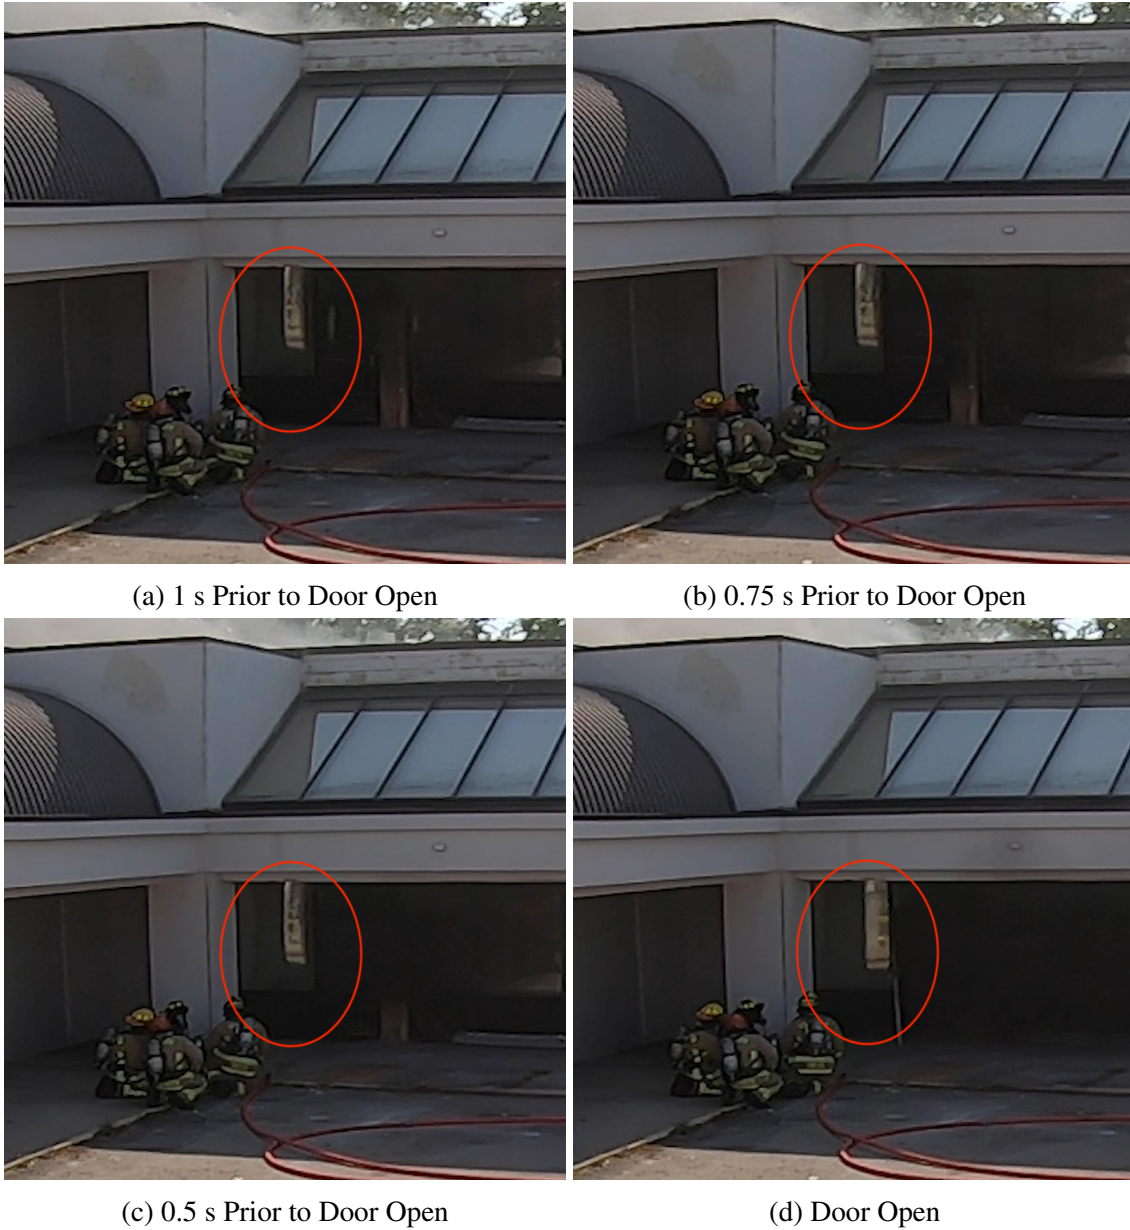
Figure 4.28: A series of images that show the pressure rise in Experiment 1 from 1 s prior to the door opening to the door opening. The reflection in three images prior to the door open show an outward bow of the glass, an indication of built-up pressure in the unit. Following the door opening, the reflection flattened out as the pressure inside the unit dropped.

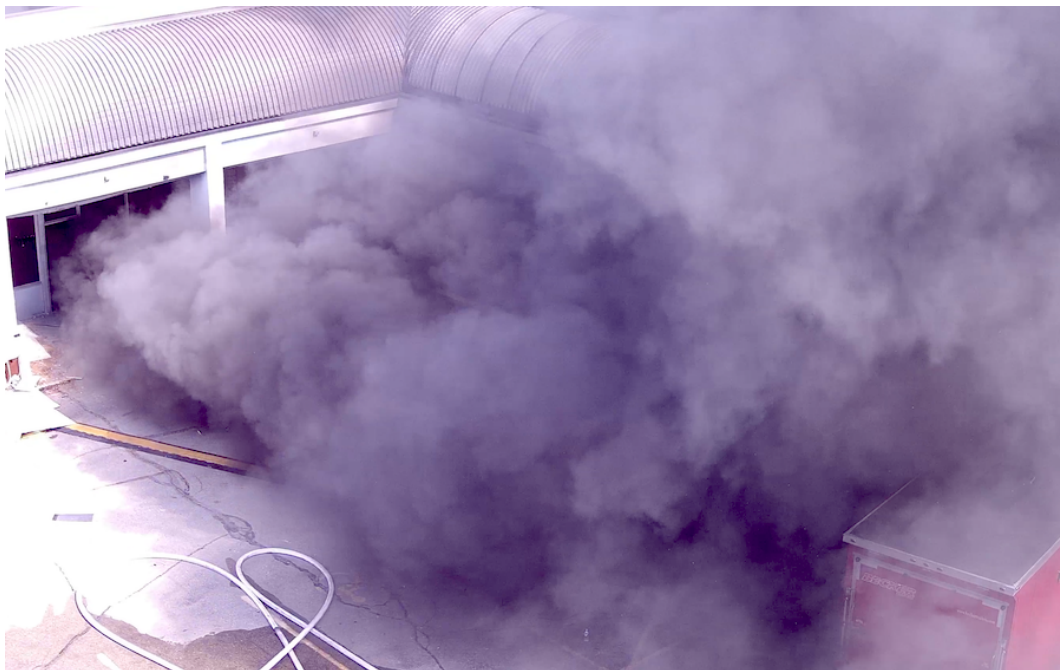
Figure 4.31: A drone image shows the peak of the smoke exhaust during Experiment 4.

The most pronounced example of the exhaust flow for experiments with an open door occurred during Experiment 4, as seen in Figure 4.30 and 4.31. The exhaust flow extended over 75 ft (22.9 m) out the front door of the unit and lasted for 45 s.

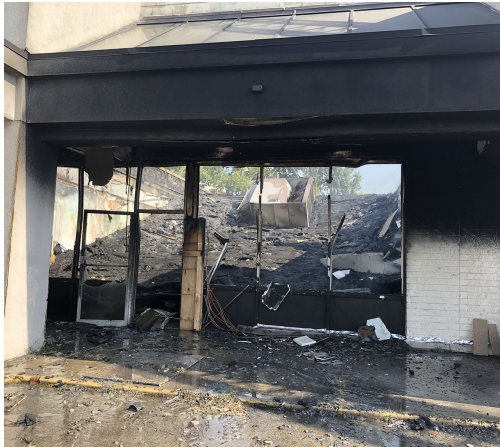
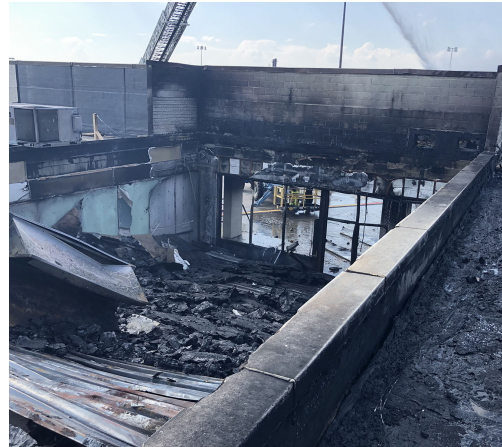
(a) Front Elevation

(b) From Adjacent Roof

Figure 4.38: Images of the lean-to front roof collapse that occurred in Experiment 2.

In Experiment 2, this damage resulted in a significant lean-to roof collapse during the overhaul phase 34 min 51 s after ignition. As water was directed from the exterior onto the open web steel

bar joists from below, the front section of the roof separated from the front masonry load-bearing wall and collapsed. Figure 4.38 presents images of the roof structure and masonry load-bearing wall after the collapse had occurred.

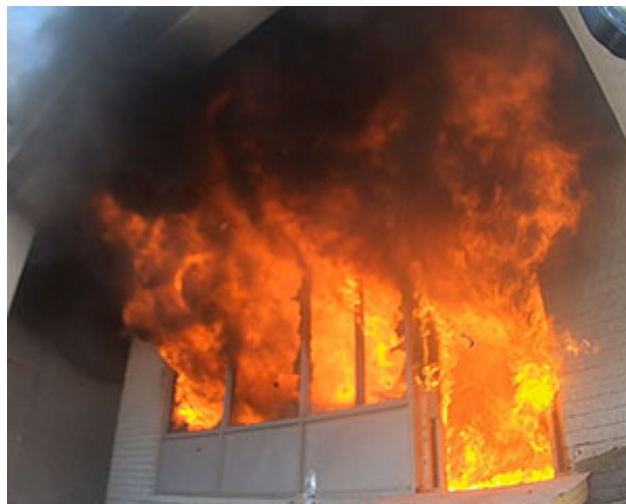
Figure 5.3: An image from Experiment 3 after all of the front windows were opened during the initial growth of the fire.

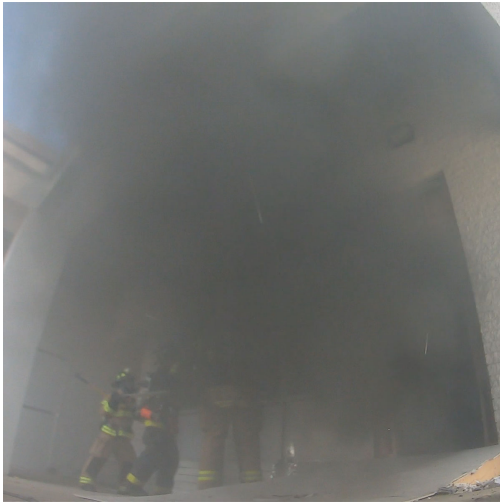
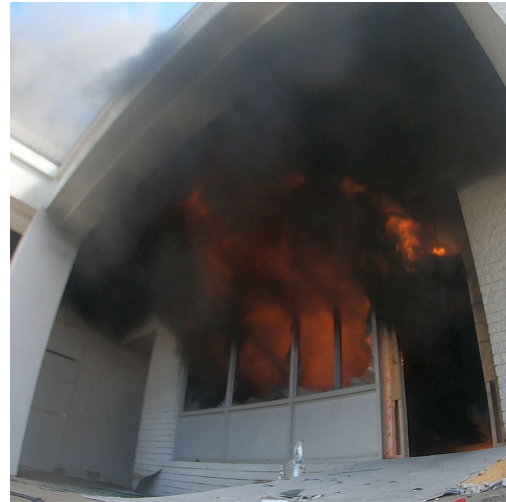
(c) Front Image Prior To Ventilation

(d) Front Image 30 s Post Ventilation

Figure 5.8: The impact of additional horizontal ventilation during the overpressure smoke exhaust event on pressure and temperature; images show the visual fire development (Experiment 3). Positive pressure values represent a rise in pressure in the fire compartment.

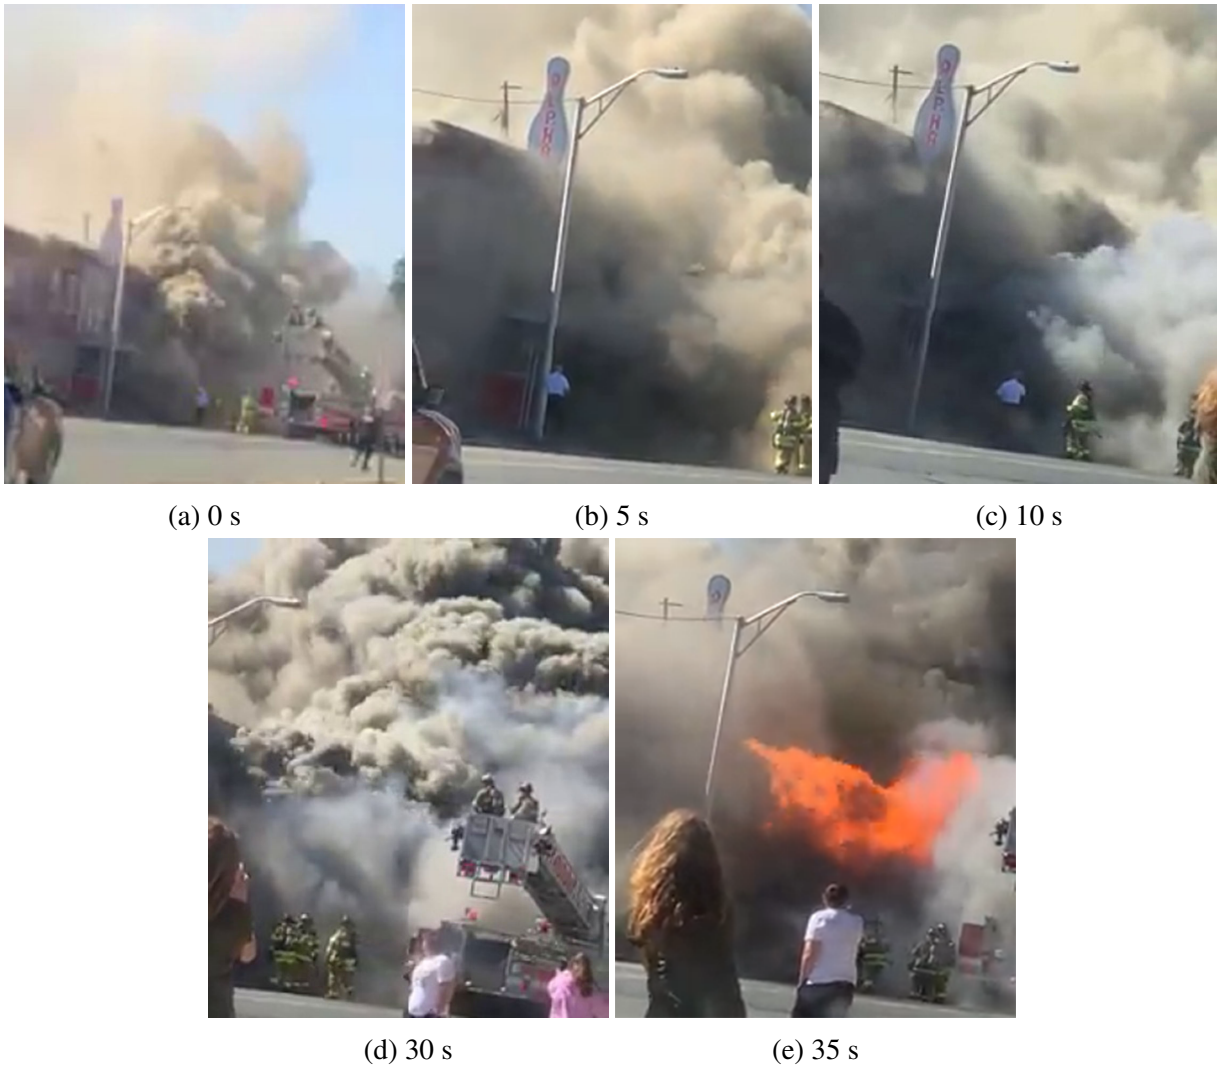
Figure 5.9: Images taken from a video of a fire in Troy, NY at the Alpha Lanes Bowling Alley on May 8, 2019. These time-lapse images are separated by varying time intervals avoid obstructed views from the by-standers [44].

Similar events have been documented during fire department operations (see Figure 5.9). A fire in a bowling ally in Troy, NY, resulted in a significant smoke and fire exhaust during fire department operations. With the limited viewpoint, it is difficult to determine exactly what caused this event,

but the exhaust out of the open vents is similar to what was observed in the above experiments. Unlike the events from these experiments, this fire resulted in flames out an opening during the unidirectional exhaust as the hot products of combustion mixed with oxygen on the exterior.

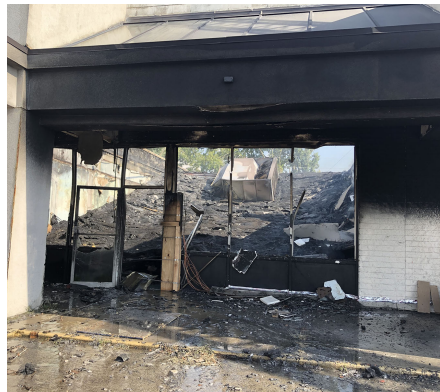
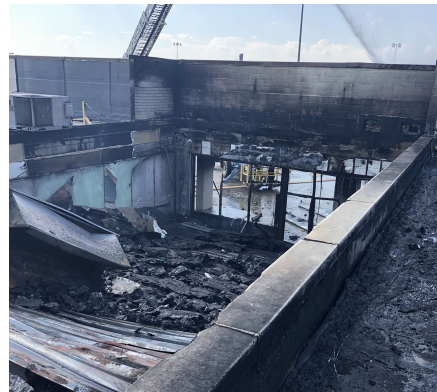
(a) Front Elevation

(b) From Adjacent Roof

Figure 5.12: Images of lean-to front roof collapse from Experiment 2.

Late in Experiment 2, a lean-to collapse occurred, potentially due to the contraction of the open web steel bar joists as they cooled and retracted from the supporting masonry wall (see Figure 5.12). This collapse occurred after the fire had been placed under control, and the crews were

extinguishing hot spots more than 30 min after the fire started. The open web steel bar joists were deformed prior to the collapse, providing an indication they were compromised.
